Solicitation Number
DACA21-03-R-0070
Ranger Barracks Complex
Volume IV of IV – Asbestos Reports
FY-04, Line Item 51127
November 2003

Asbestos Survey

**Building No. 1275 Hunter Army Air Field,
Georgia**

Asbestos Inspection Report

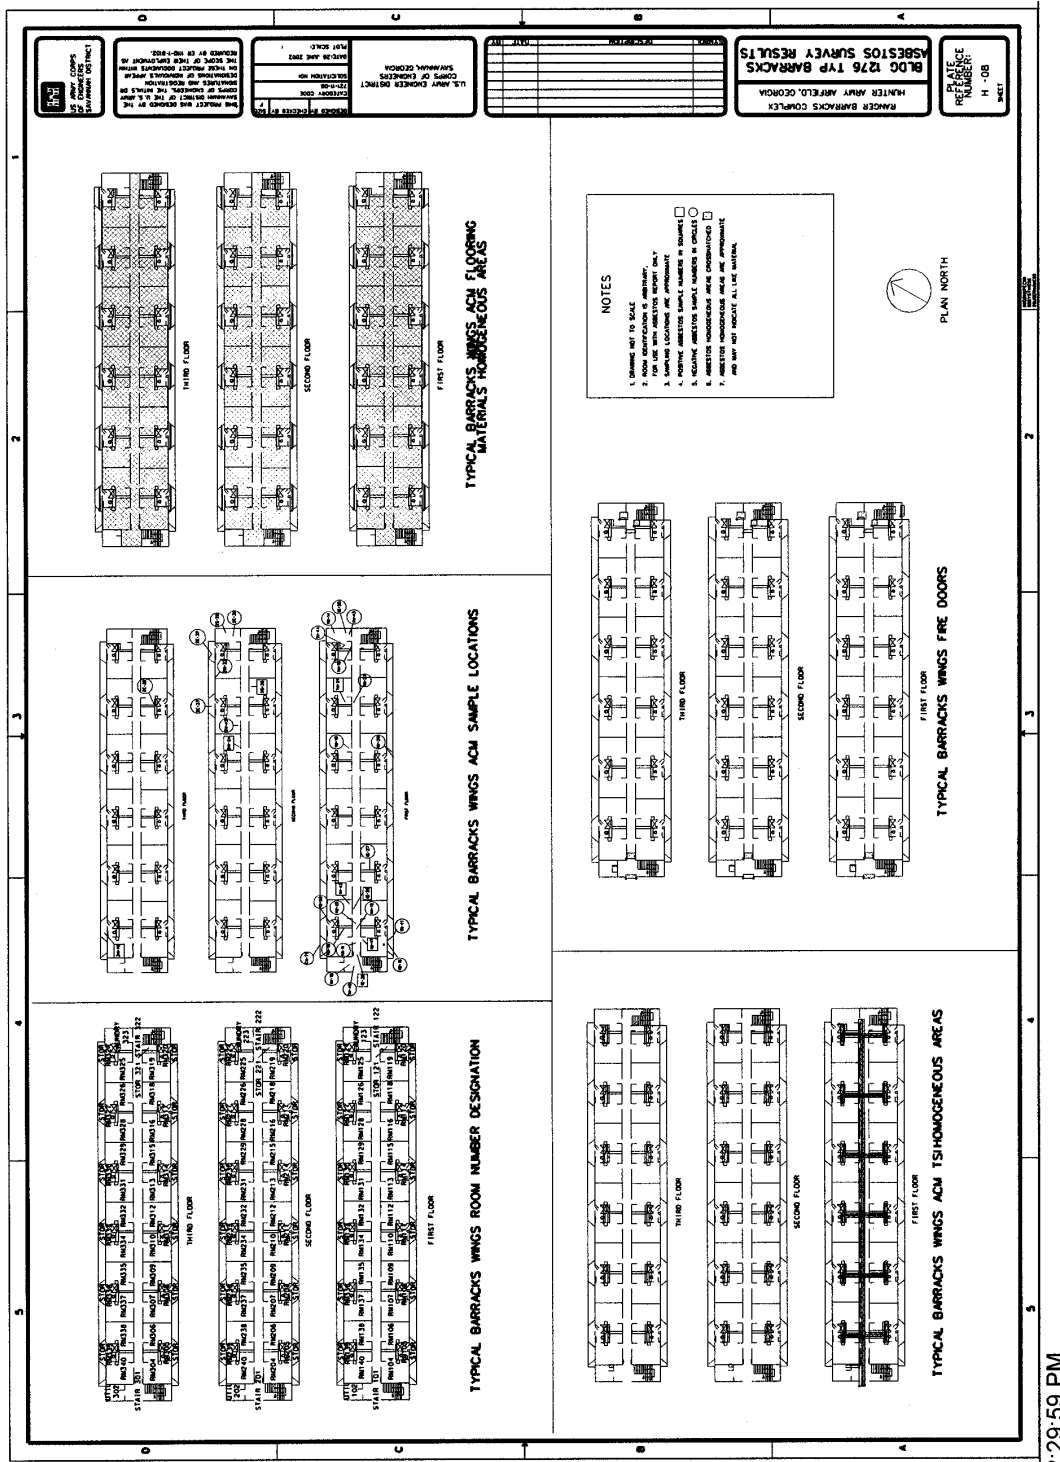
Figure 4

Figure 1. HFHH105.dgn – Admin. Area Survey Results.....	16
Figure 2. HFHH106.dgn – Recreation Area Survey Results	17
Figure 3. HFHH107.dgn – Rec. Area & Barracks Wing Roof Survey Results .	18
Figure 4. HFHH108.dgn – Barracks Wings Survey Results.....	19
